APPENDIX I

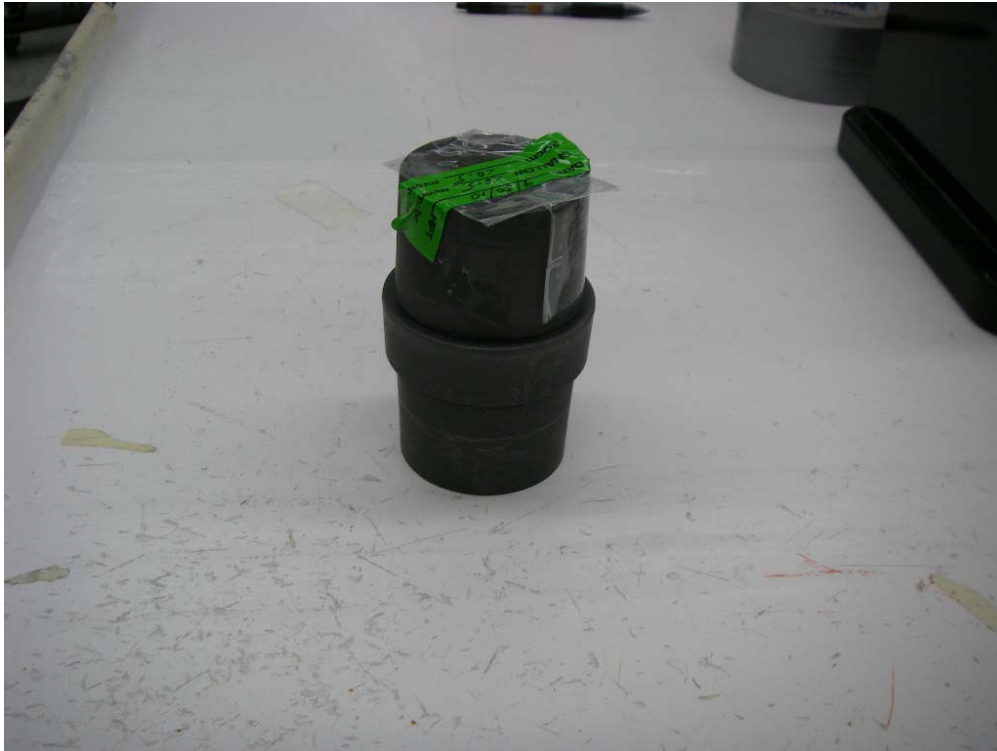
Photo#: IMGP0055 Date/Time: 3/17/2011 2:37:37 PM Photographer: A. Ruhs
Description: Example of tank sample carrier that would get deconed in hood-sink in room 2B at 222S Lab.

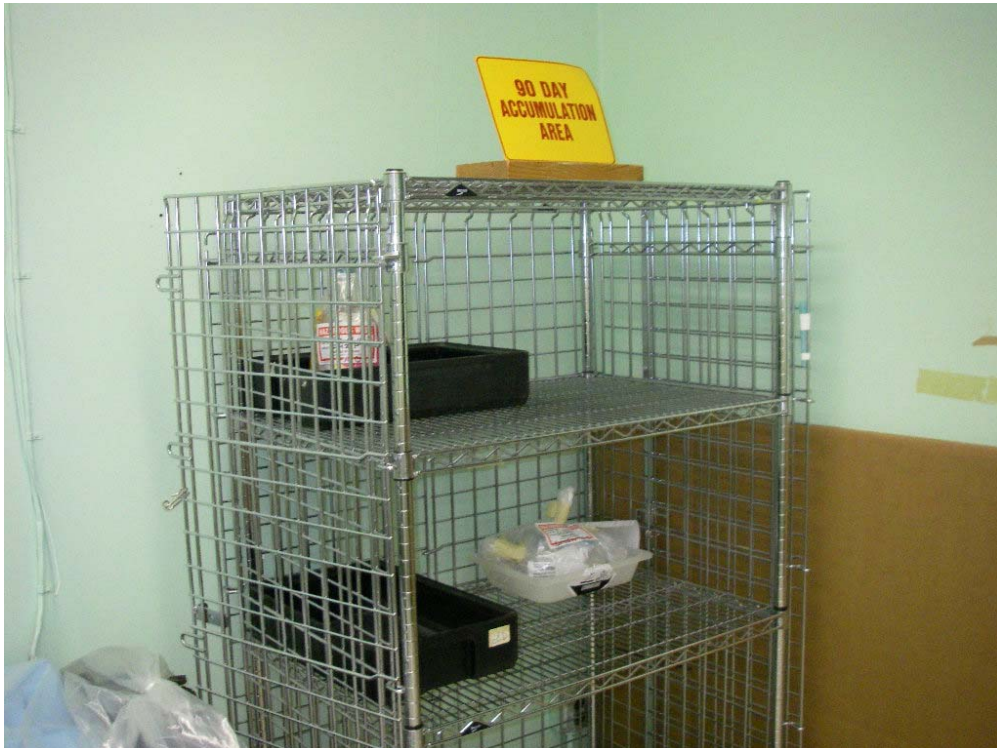
Photo#: IMGP0056 Date/Time: 3/17/2011 2:55:35 PM Photographer: A. Ruhs
Description: Less-than-90-day accumulation for MLLW inside of the 222S lab area.

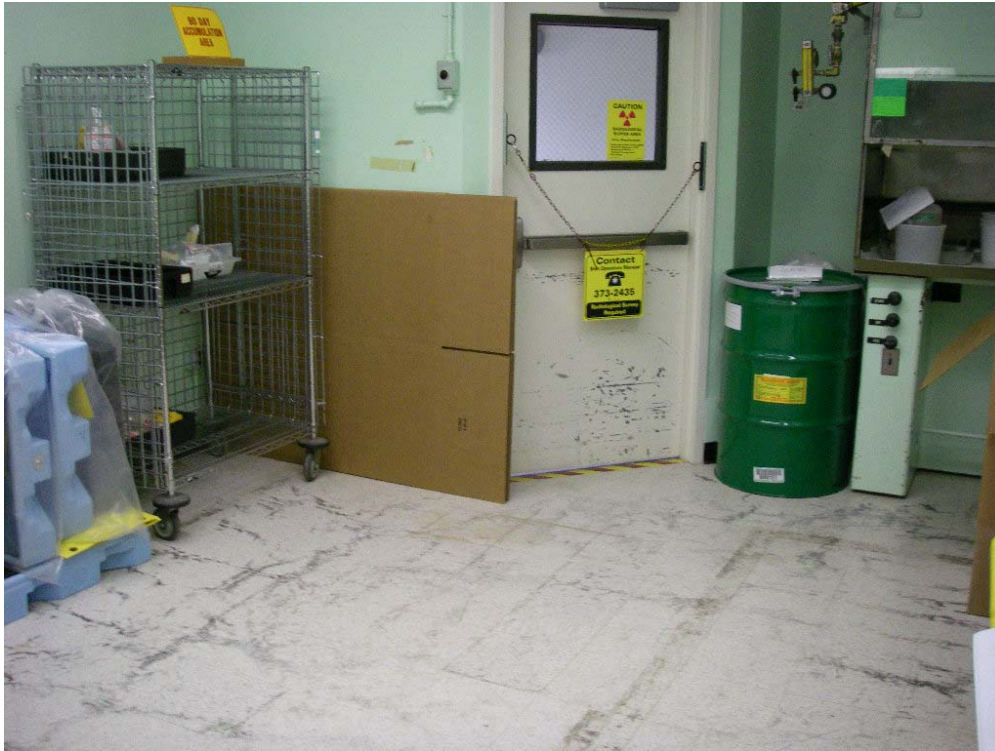
Photo#: IMGP0057 Date/Time: 3/17/2011 2:55:44 PM Photographer: A. Ruhs
Description: Overview of MLLW storage and less-than-90-day accumulation rack in the 222S lab.

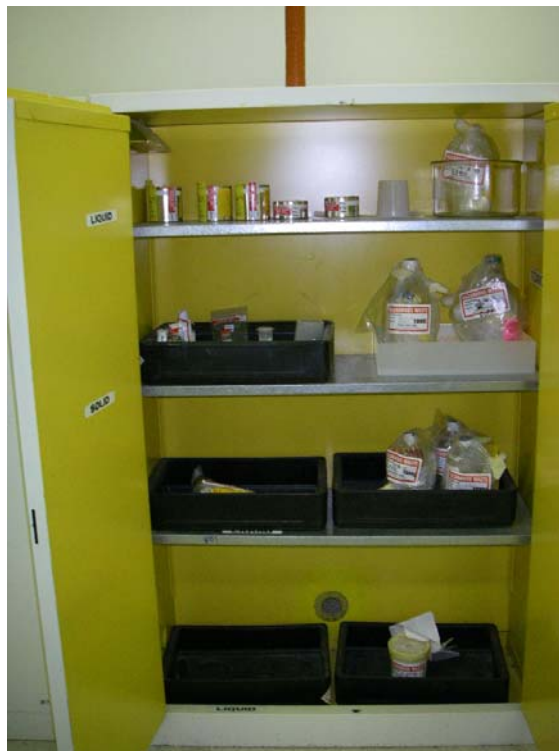
Photo#: IMGP0058 Date/Time: 3/17/2011 2:59:17 PM Photographer: A. Ruhs
Description: storage cabinet for MLLW in room 4E at 222S lab. DWMU

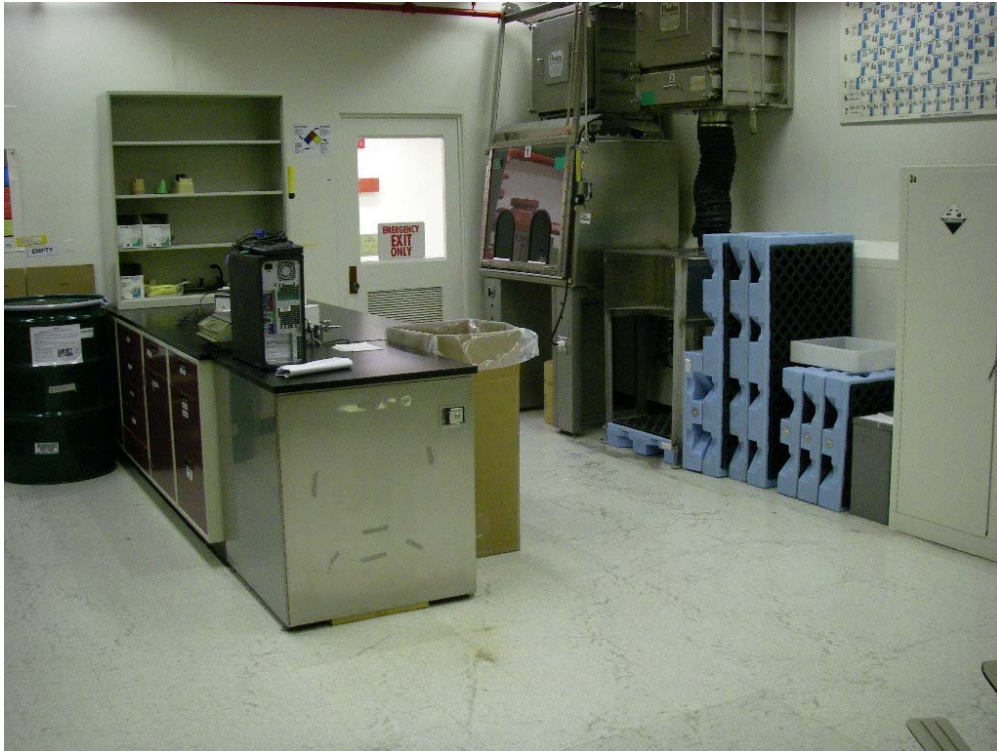
Photo#: IMGP0059 Date/Time: 3/17/2011 3:03:36 PM Photographer: A. Ruhs
Description: Overview of room 4E at Lab 222S. DWMU

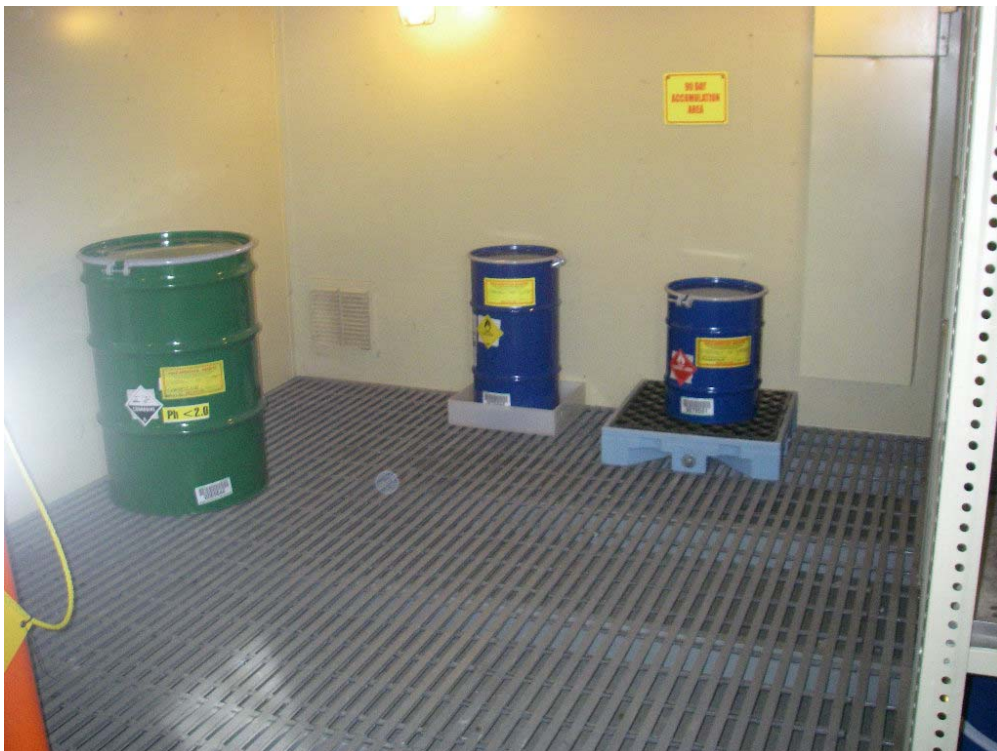
Photo#: IMGP0060 Date/Time: 3/17/2011 3:45:02 PM Photographer: A. Ruhs
Description: DW-only drums in the less-than-90-day accumulation area at 222S lab.

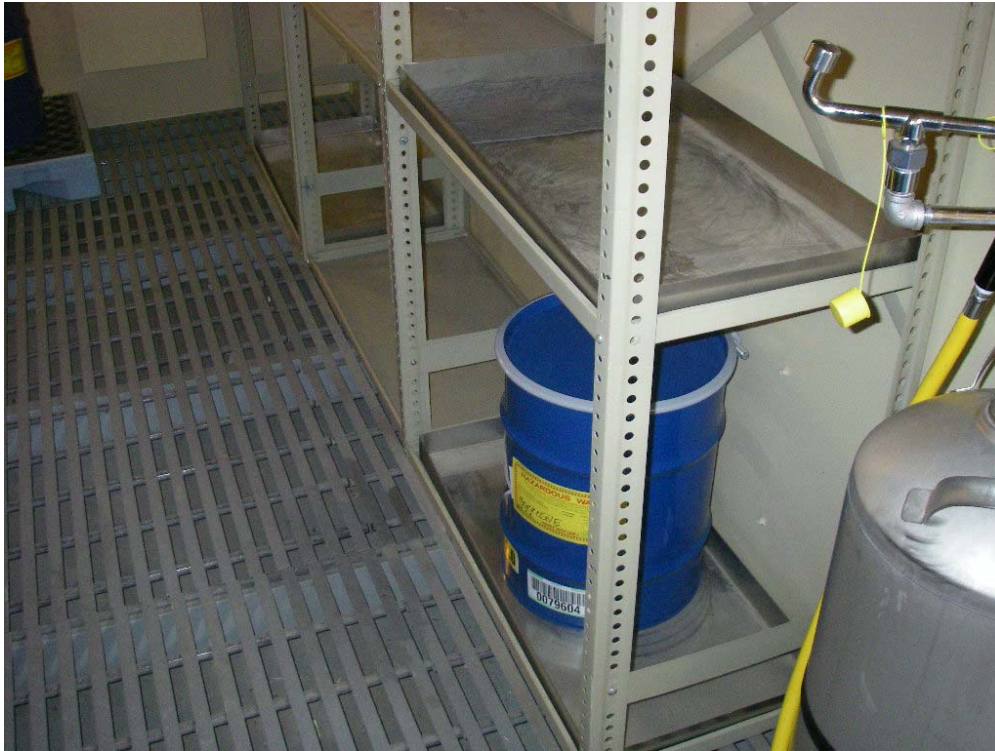
Photo#: IMGP0061 Date/Time: 3/17/2011 3:45:09 PM Photographer: A. Ruhs
Description: close-up on drum in DW-only less-than-90-day accumulation area at 222S lab.

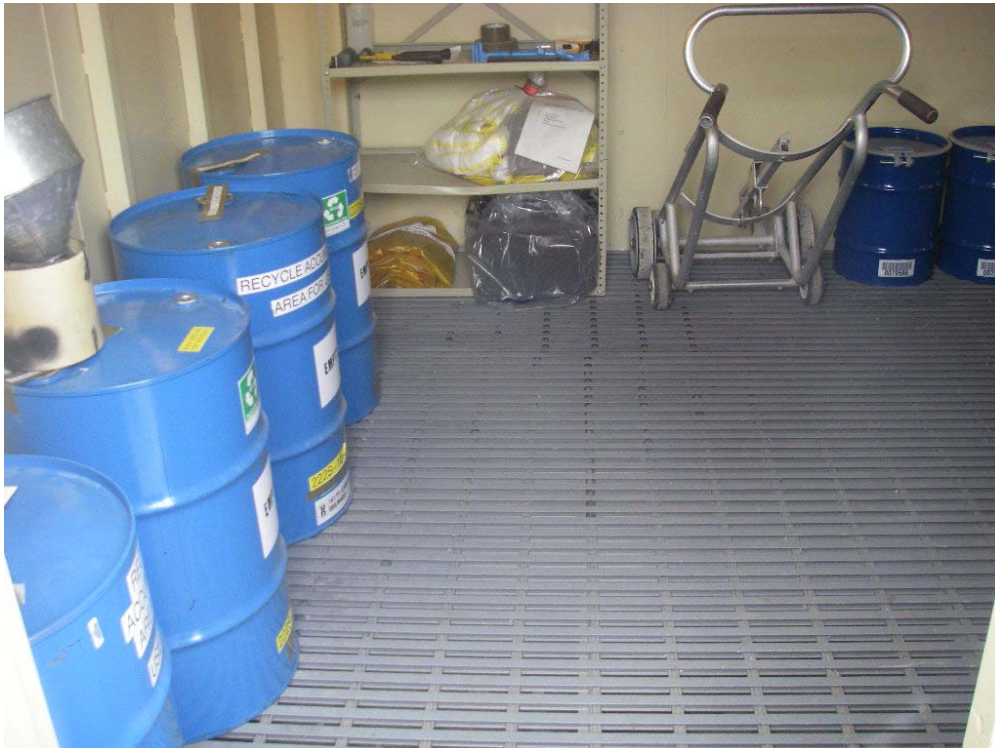
Photo#: IMGP0062 Date/Time: 3/17/2011 3:45:29 PM Photographer: A. Ruhs
Description: Used-oil drums stored in the DW-only less-than-90-day accumulation building at lab 222S.

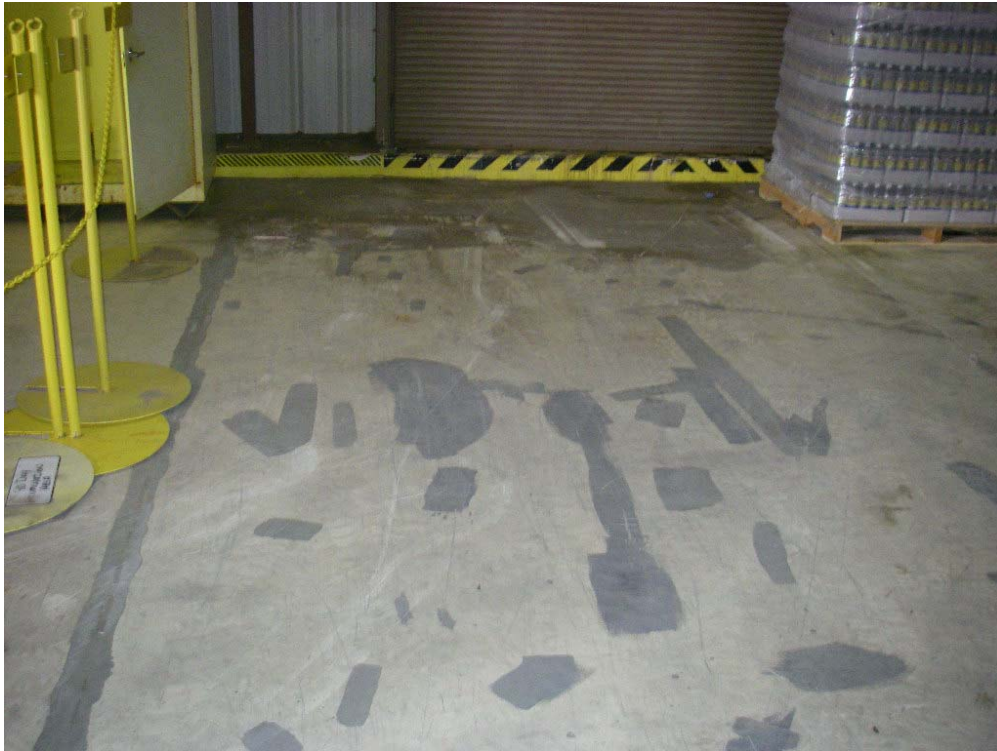
Photo#: IMGP0063 Date/Time: 3/21/2011 10:57:12 AM Photographer: A. Ruhs
Description: Inside of 2401W building at CWC. This area has been used for less-than-90-day accumulation and is roped off during that time.

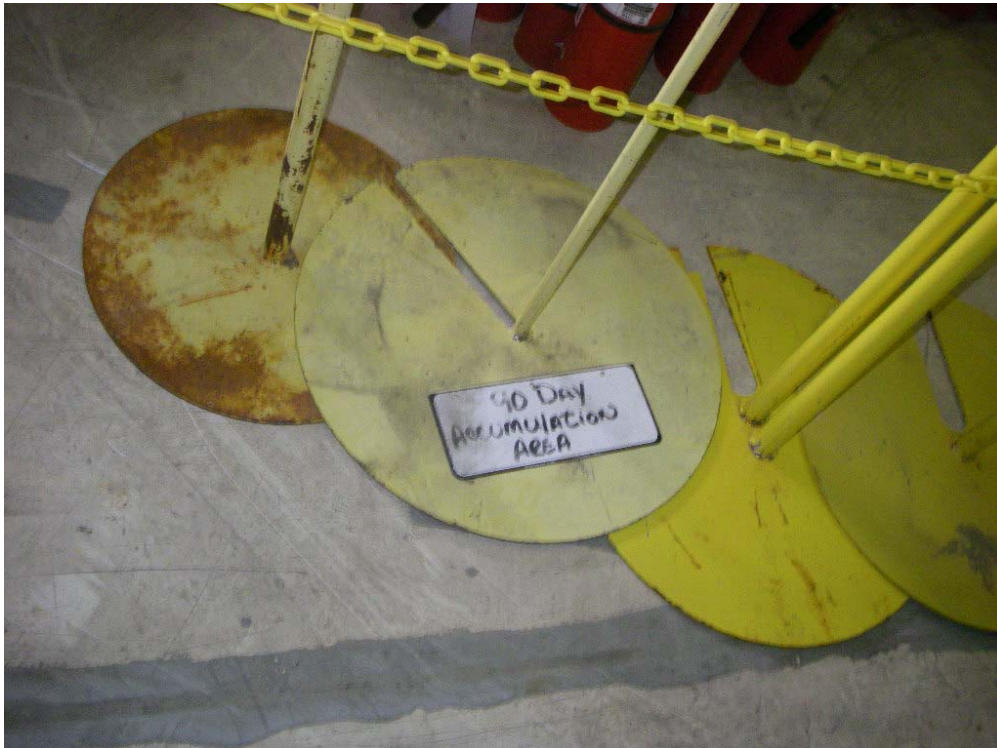
Photo#: IMGP0064 Date/Time: 3/21/2011 10:57:20 AM Photographer: A. Ruhs
Description: Close-up on the label on the poll used to rope off the less-than-90-day accumulation area in building 2401W when in use. Located in the CWC facility.

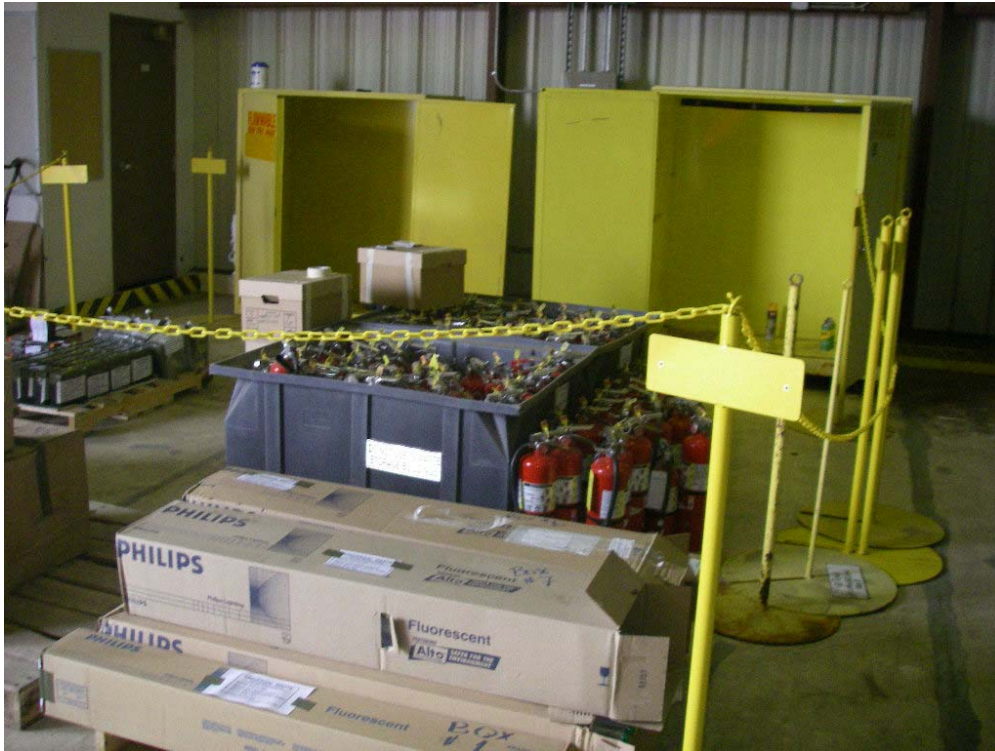
Photo#: IMGP0065 Date/Time: 3/21/2011 10:57:52 AM Photographer: A. Ruhs
Description: Recycling and universal waste storage inside of building 2401W at CWC facility.

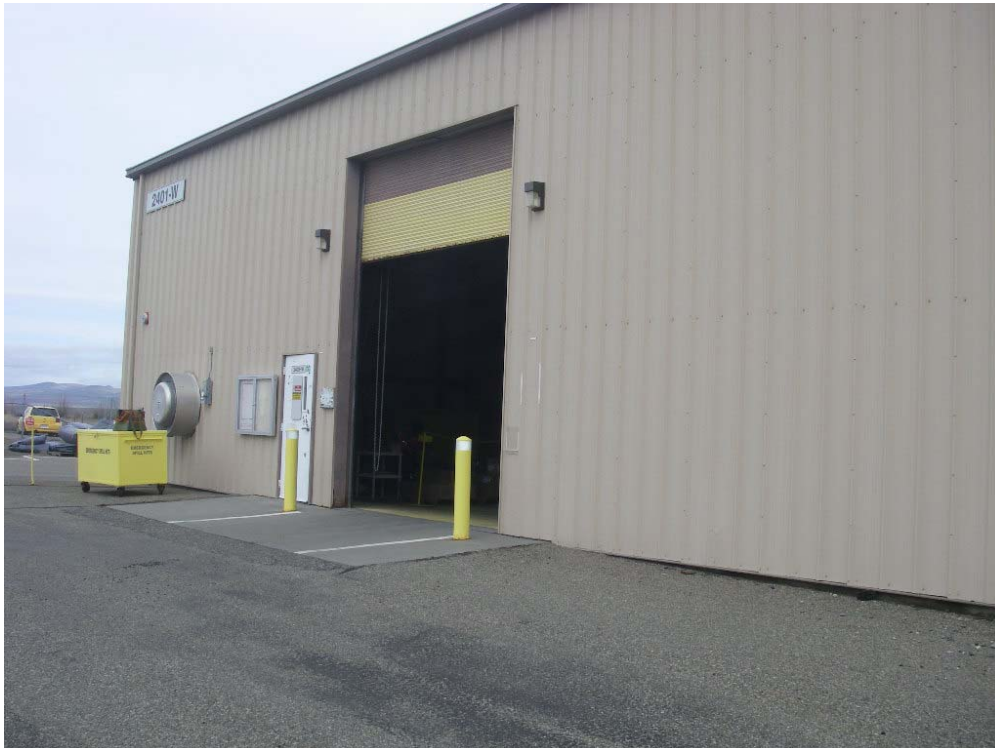
Photo#: IMGP0066 Date/Time: 3/21/2011 10:59:14 AM Photographer: A. Ruhs
Description: Outside view of building 2401W at CWC facility.

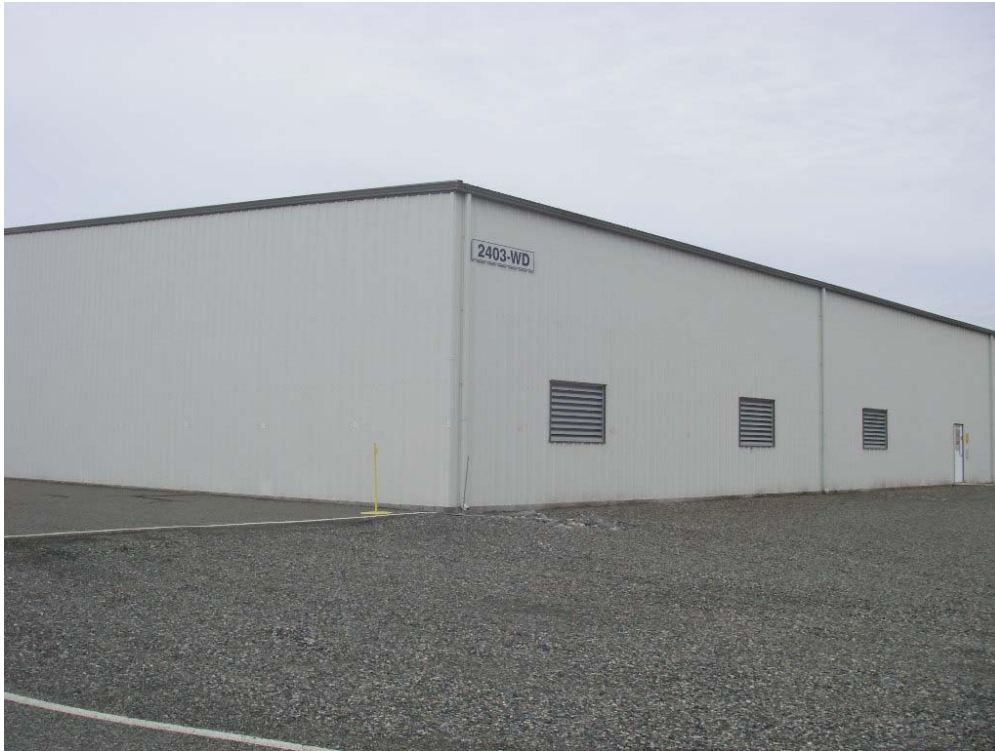
Photo#: IMGP0067 Date/Time: 3/21/2011 11:06:02 AM Photographer: A. Ruhs
Description: Outside of storage building 2403WD building at CWC.

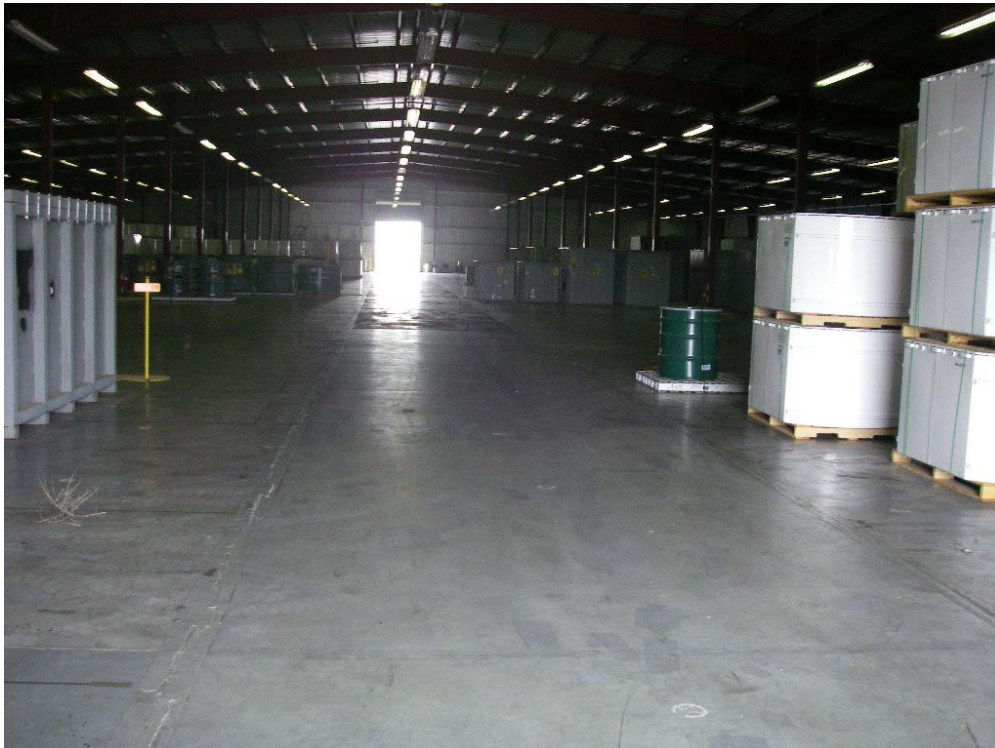
Photo#: IMGP0068 Date/Time: 3/21/2011 11:08:20 AM Photographer: A. Ruhs
Description: Inside overview shot of building 2403WD at CWC facility.

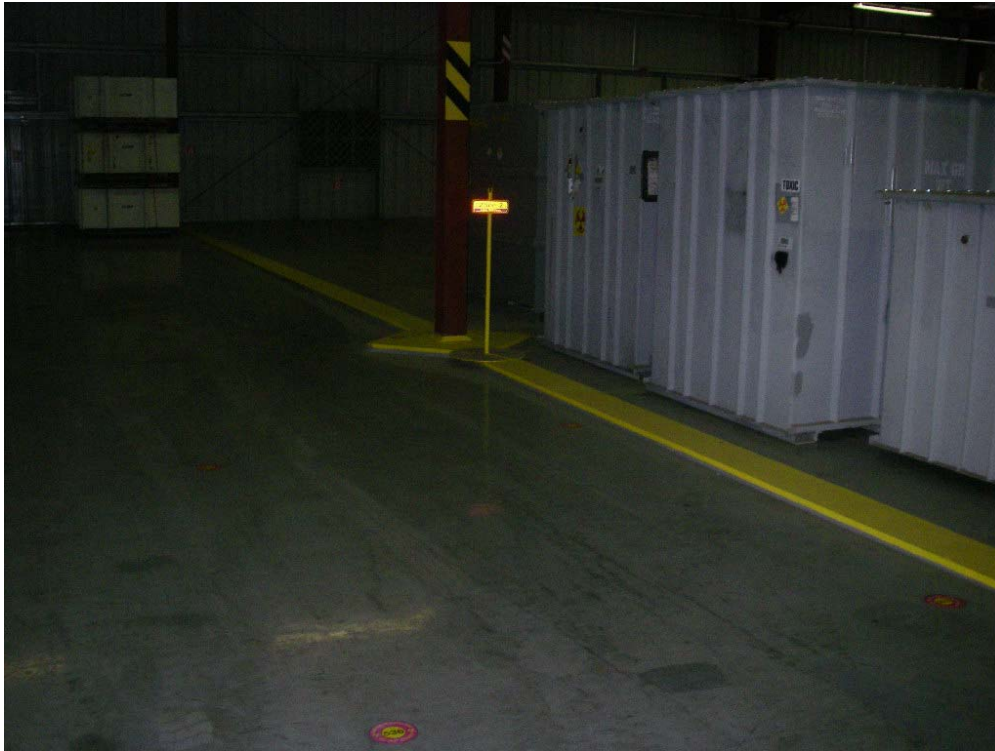
Photo#: IMGP0069 Date/Time: 3/21/2011 11:17:30 AM Photographer: A. Ruhs
Description: Shows berm and slope in floor used for separation inside of building 2403WD at CWC facility.

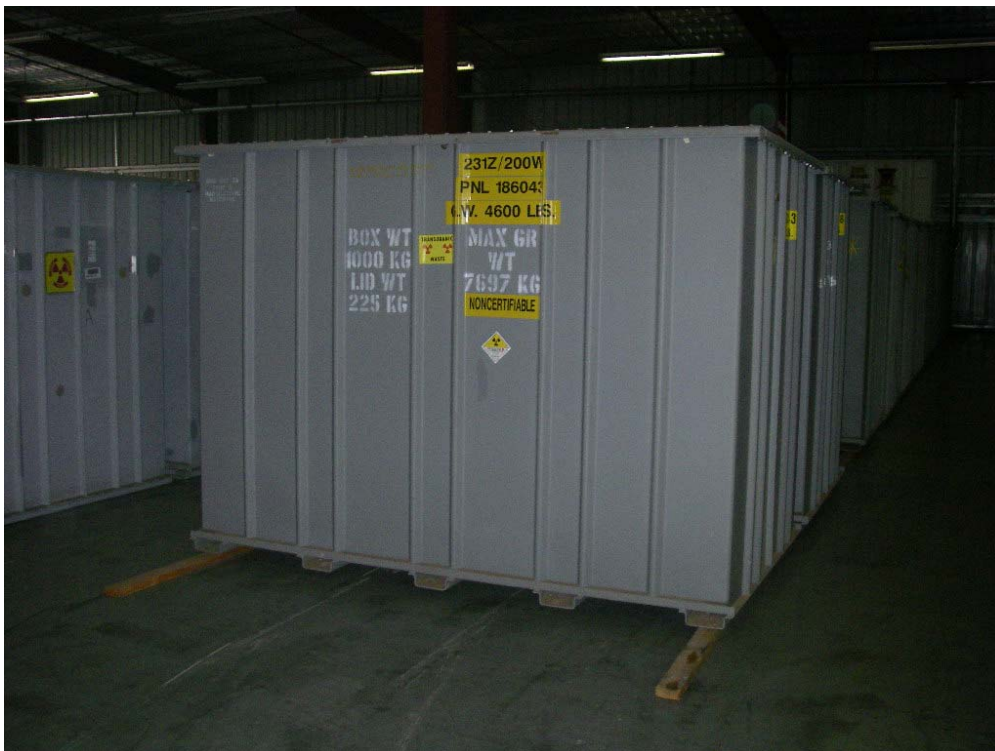
Photo#: IMGP0070 Date/Time: 3/21/2011 11:20:15 AM Photographer: A. Ruhs
Description: This box has been marked non-certifiable (came from 231Z area). Stored in 2403WD building at CWC facility.

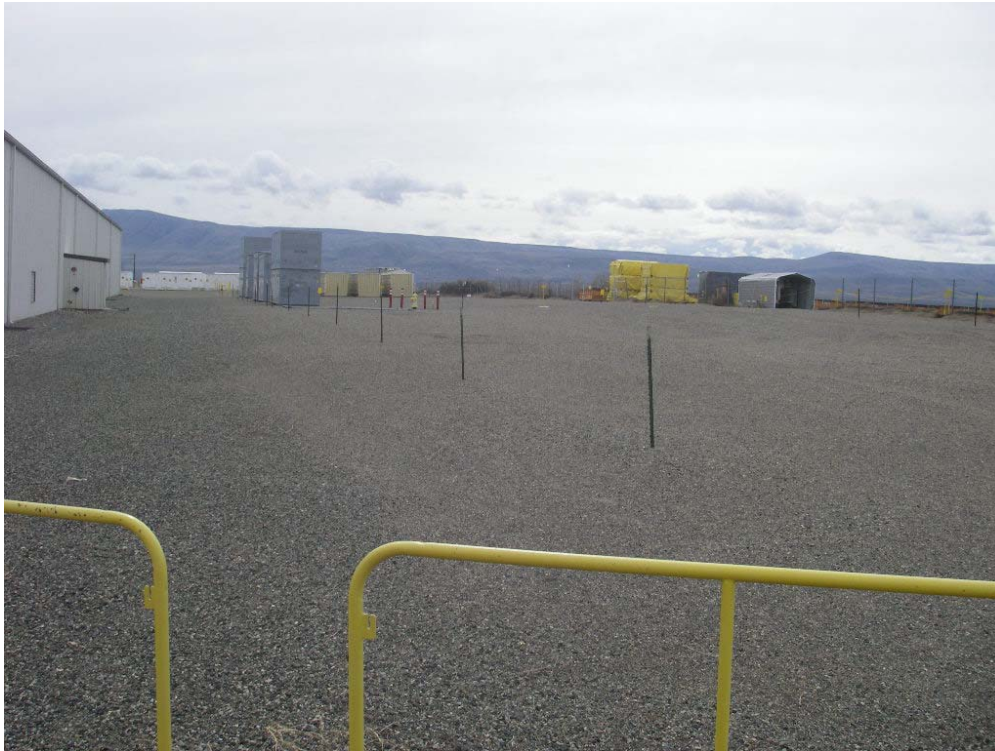
Photo#: IMGP0073 Date/Time: 3/21/2011 1:37:15 PM Photographer: A. Ruhs
Description:DWMU area - Storage area B (FRA), with 212N boxes-crates. Storage is just west of the 2403WD building.

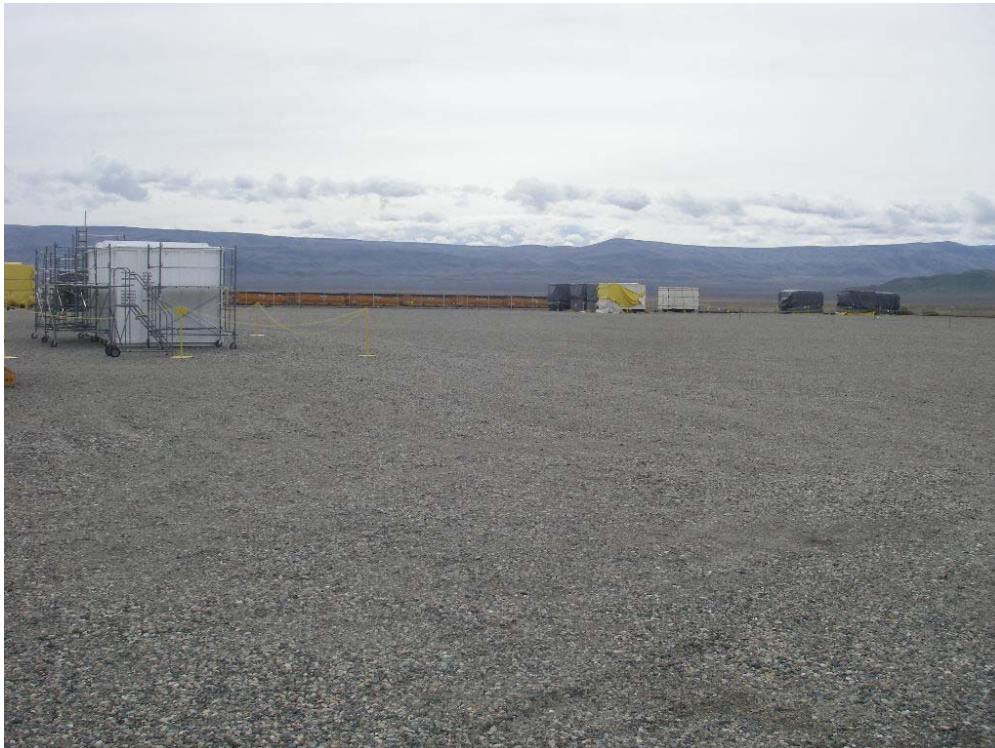
Photo#: IMGP0074 Date/Time: 3/21/2011 1:40:38 PM Photographer: A. Ruhs
Description:Expansion area (DWMU storage area A) at the CWC facility. Facing South from the middle of the storage area on the east side.

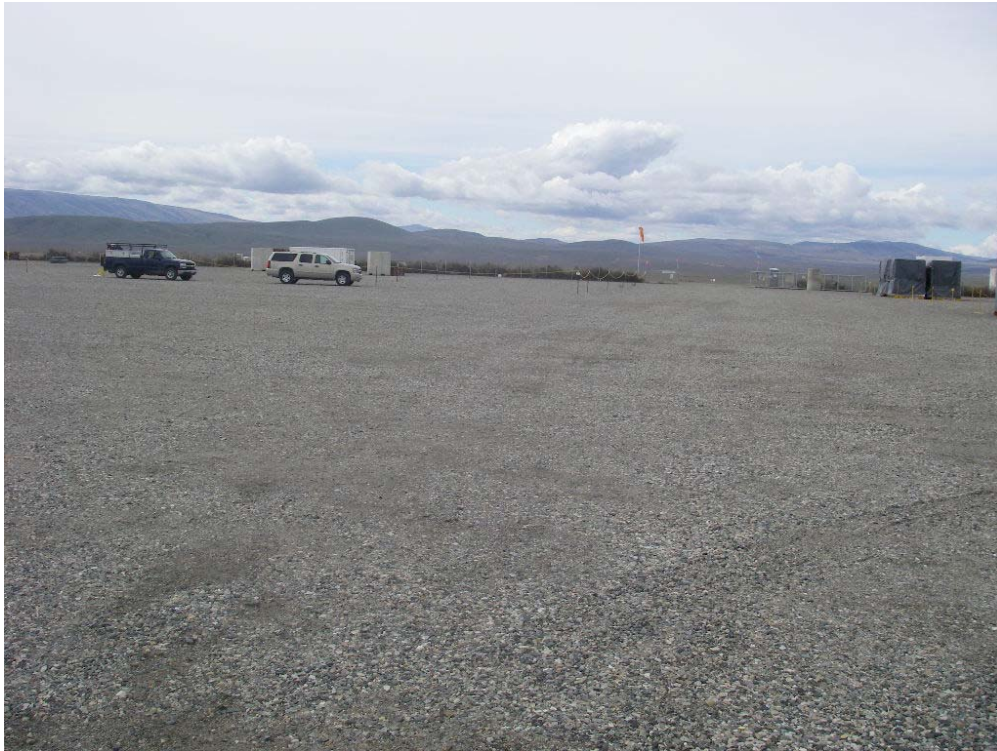
Photo#: IMGP0075 Date/Time: 3/21/2011 1:40:43 PM Photographer: A. Ruhs
Description: Expansion area (DWMU storage area A) at the CWC facility. Facing west from the middle of the storage area on the east side.

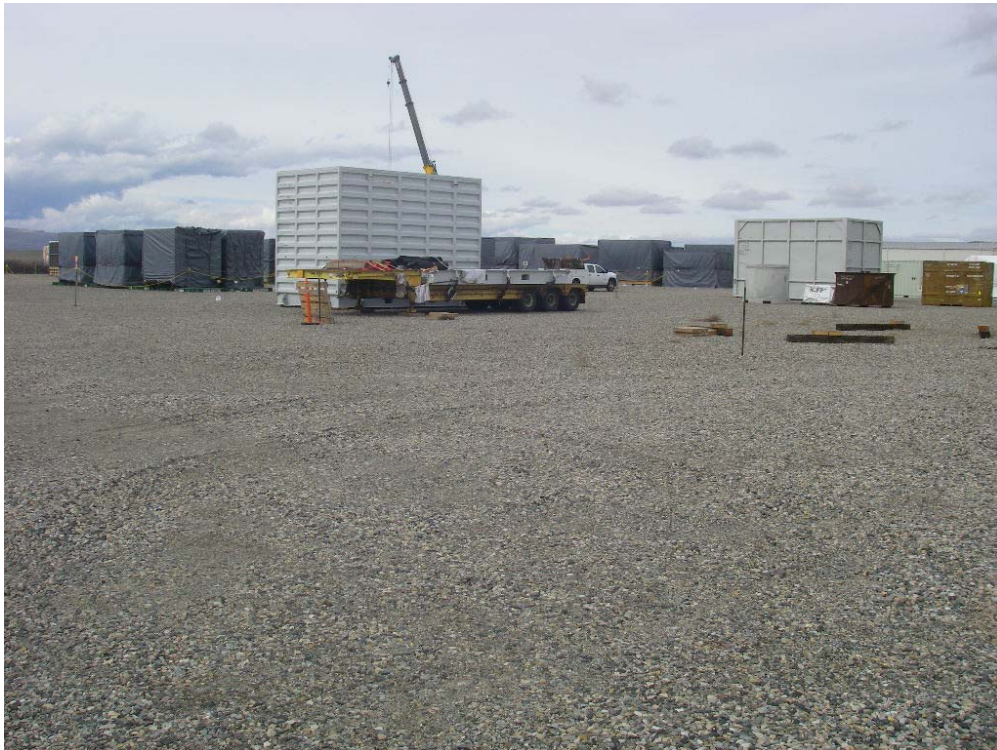
Photo#: IMGP0076 Date/Time: 3/21/2011 1:40:49 PM Photographer: A. Ruhs
Description: Expansion area (DWMU storage area A) at the CWC facility. Facing northwest from the middle of the storage area on the east side.

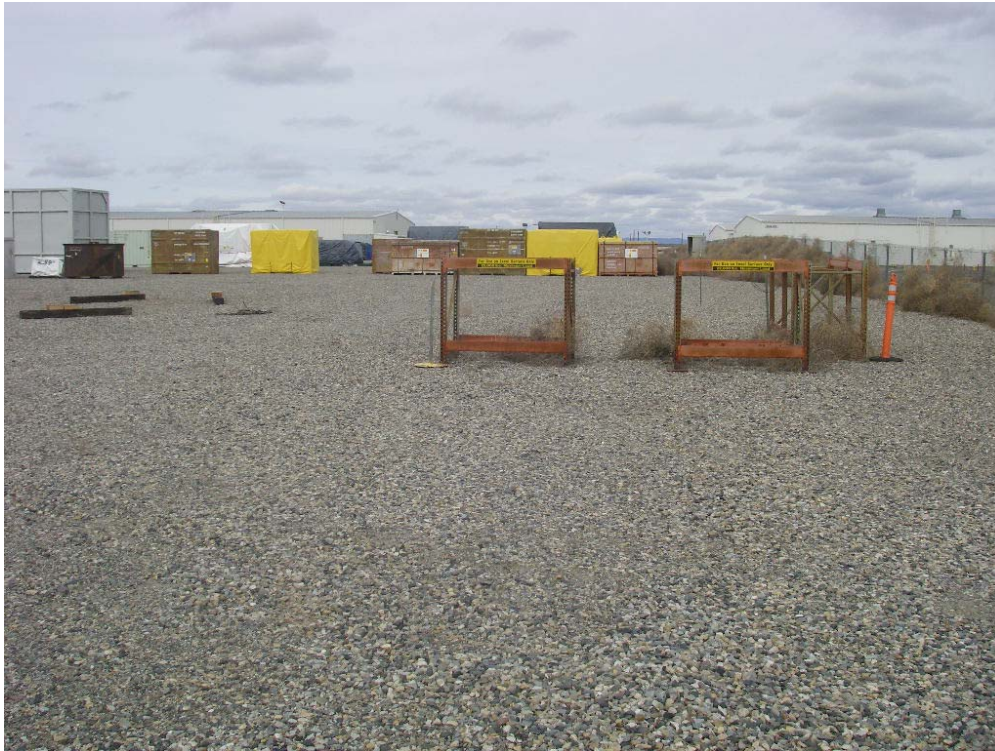
Photo#: IMGP0077 Date/Time: 3/21/2011 1:40:54 PM Photographer: A. Ruhs
Description: Expansion area (DWMU storage area A) at the CWC facility. Facing north from the middle of the storage area on the east side.

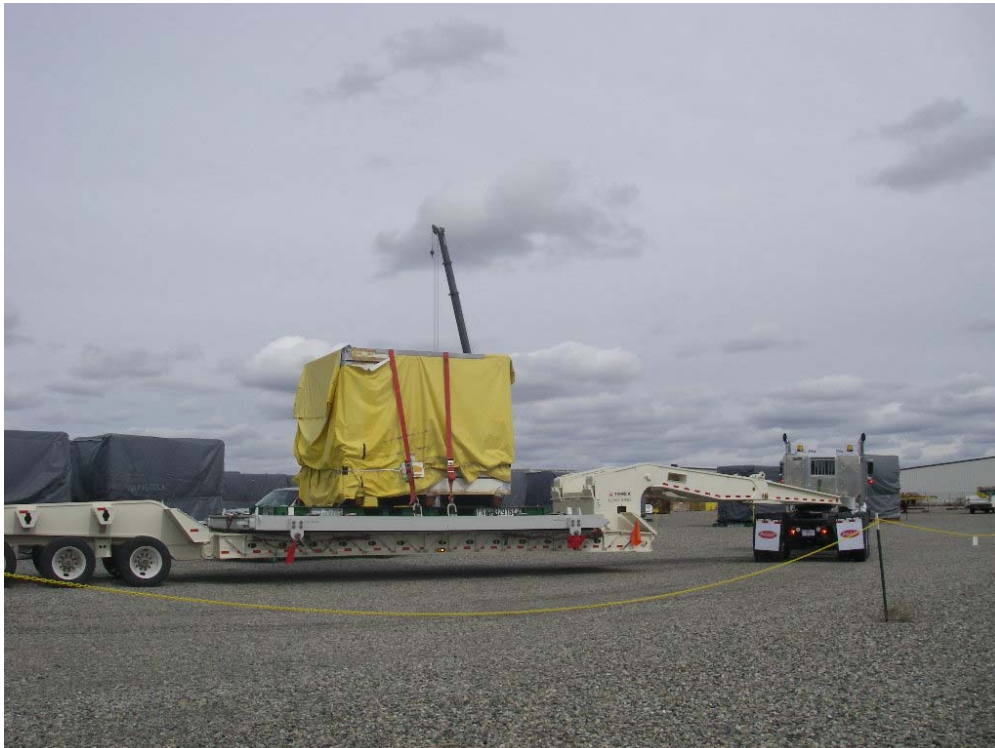
Photo#: IMGP0078 Date/Time: 3/21/2011 2:03:48 PM Photographer: A. Ruhs
Description: Truck in the process of moving s waste box at the expansion area at CWC facility. Destination is likely Permafix for treatment. Facing East.

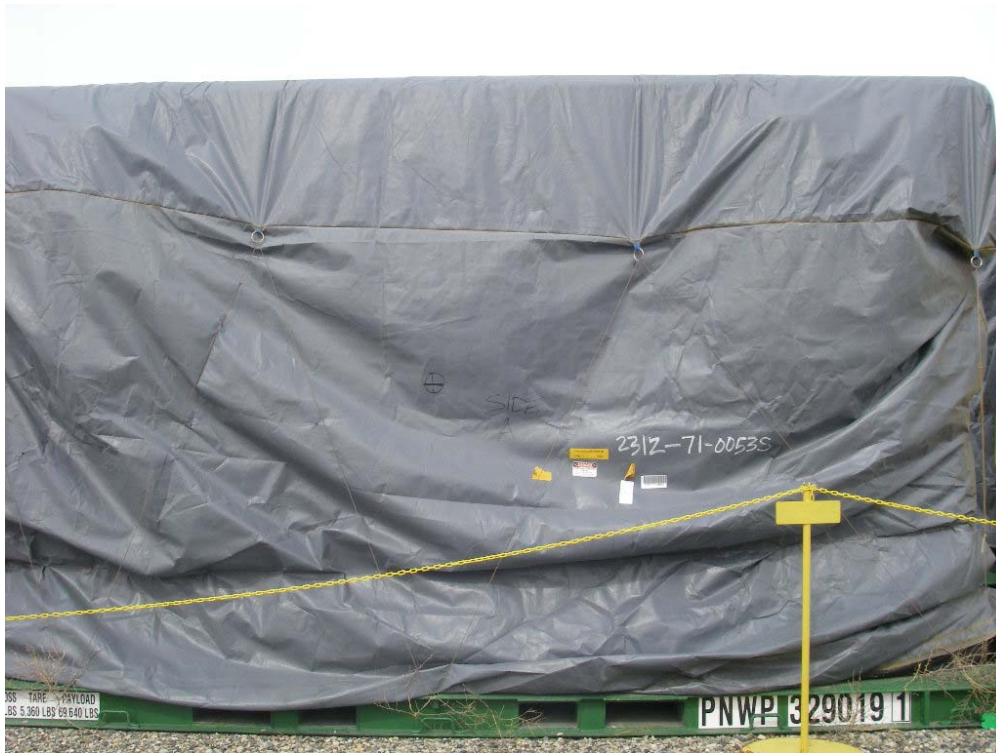
Photo#: IMGP0079 Date/Time: 3/21/2011 2:07:26 PM Photographer: A. Ruhs
Description: Tarped waste box labelled hazardous waste in the expansion area at CWC facility. North facing.

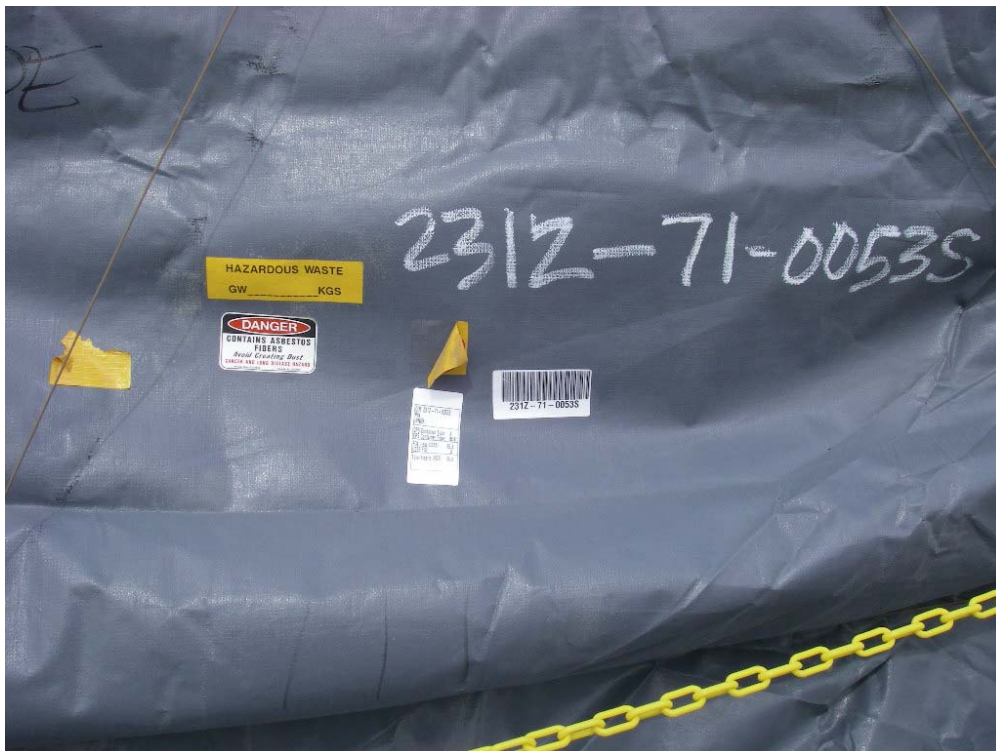
Photo#: IMGP0080 Date/Time: 3/21/2011 2:07:36 PM Photographer: A. Ruhs
Description: Close-up on labels on the tarped waste box labelled hazardous waste in the expansion area at CWC facility. North facing.

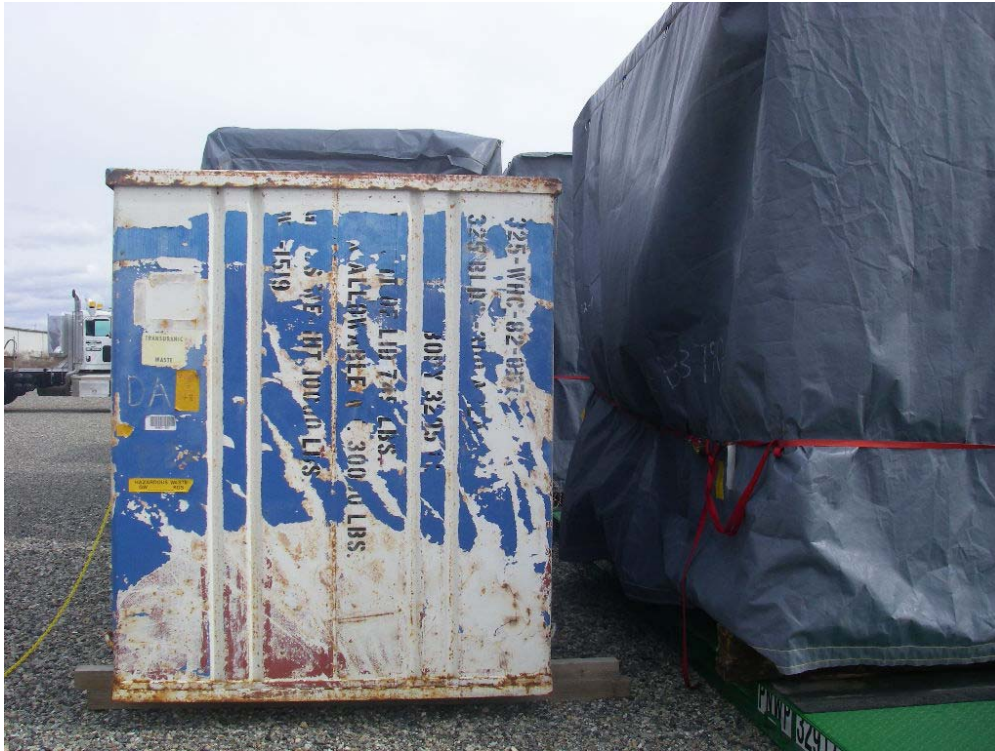
Photo#: IMGP0081 Date/Time: 3/21/2011 2:10:26 PM Photographer: A. Ruhs
Description: Waste box labelled hazardous waste in the expansion area at CWC facility. East facing.

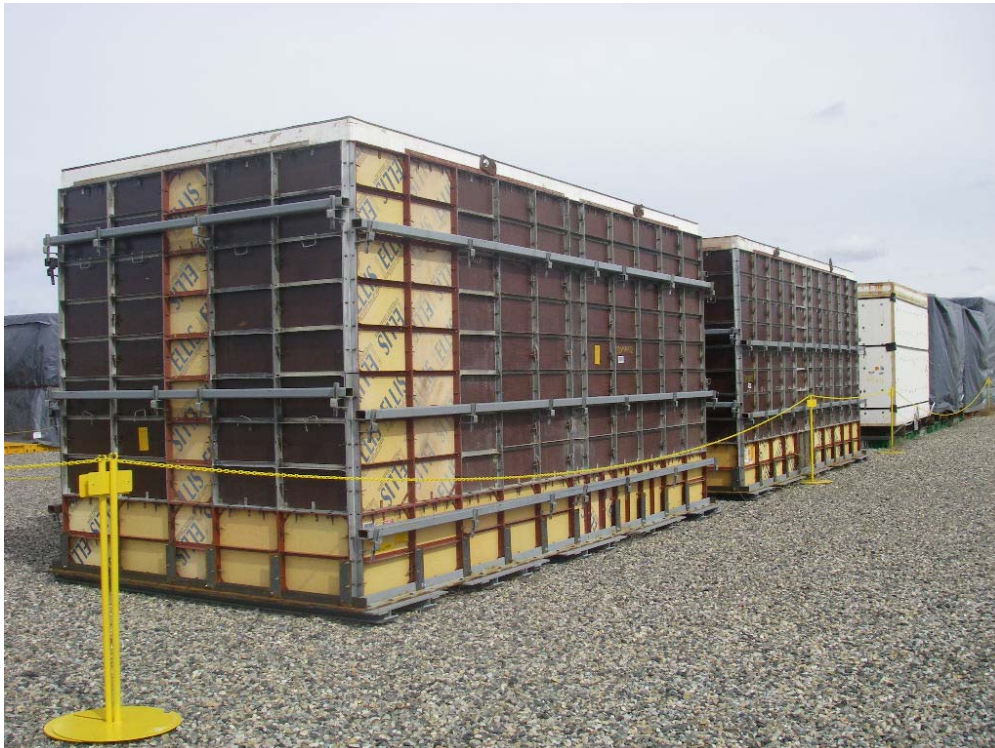
Photo#: IMGP0082 Date/Time: 3/21/2011 2:18:07 PM Photographer: A. Ruhs
Description: Waste box that has been re-enforced with concrete. Located in expansion area at CWC facility.

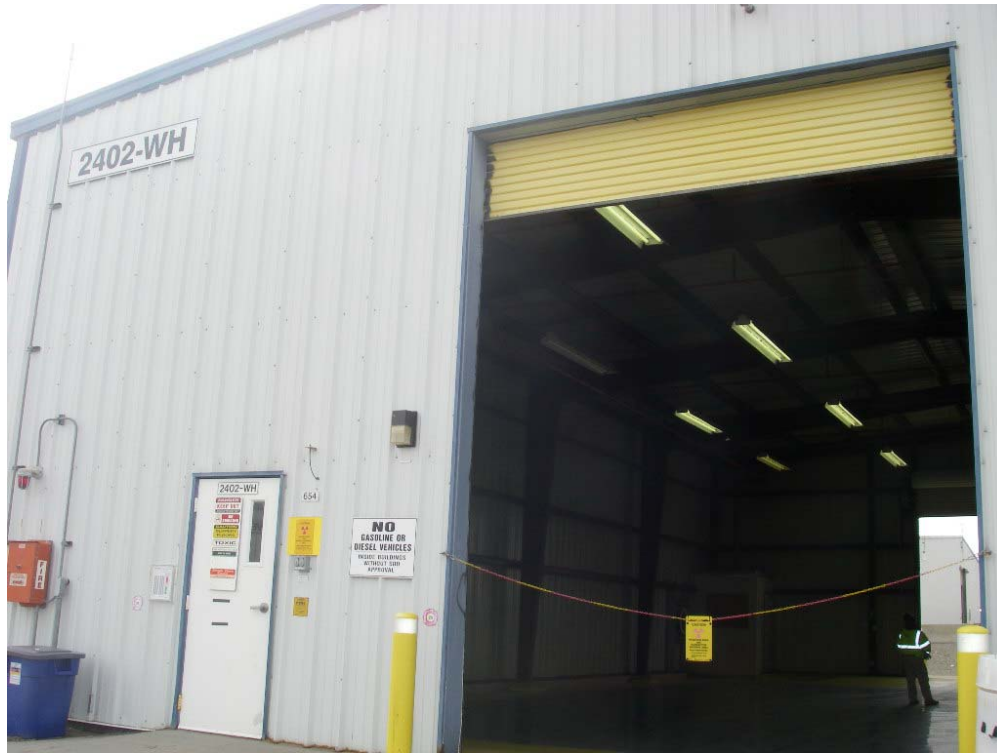
Photo#: IMGP0085 Date/Time: 3/21/2011 2:41:38 PM Photographer: A. Ruhs
Description: Outside view of 2402WH building at CWC facility.

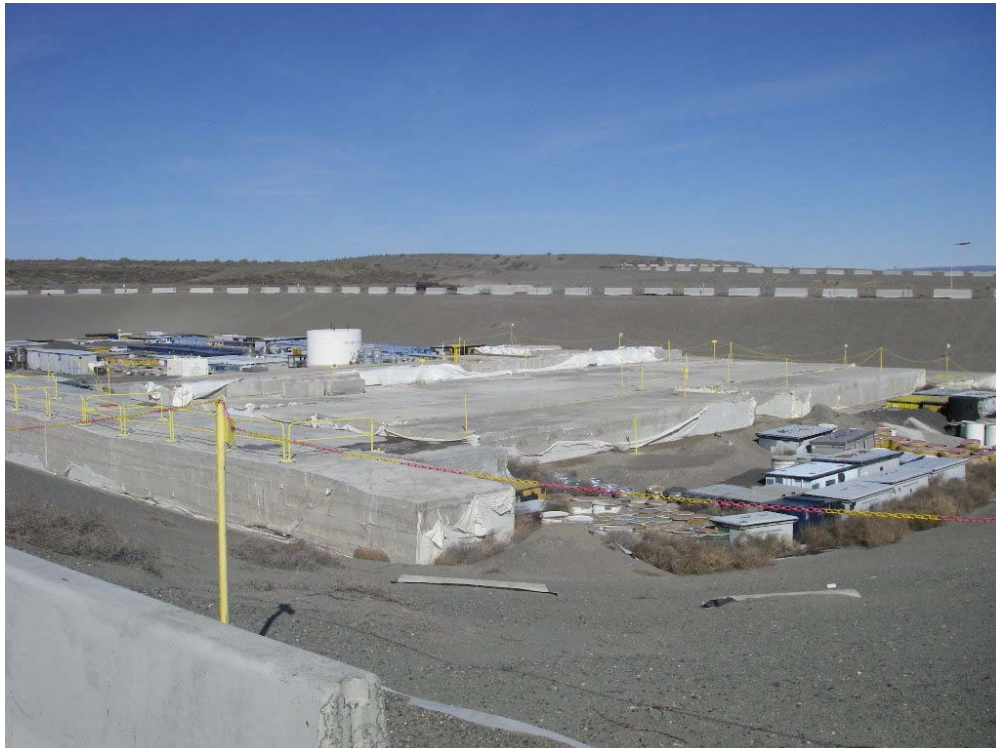
Photo#: IMGP0086 Date/Time: 3/22/2011 10:36:17 AM Photographer: A. Ruhs
Description: Overview of Trench 34. West facing.

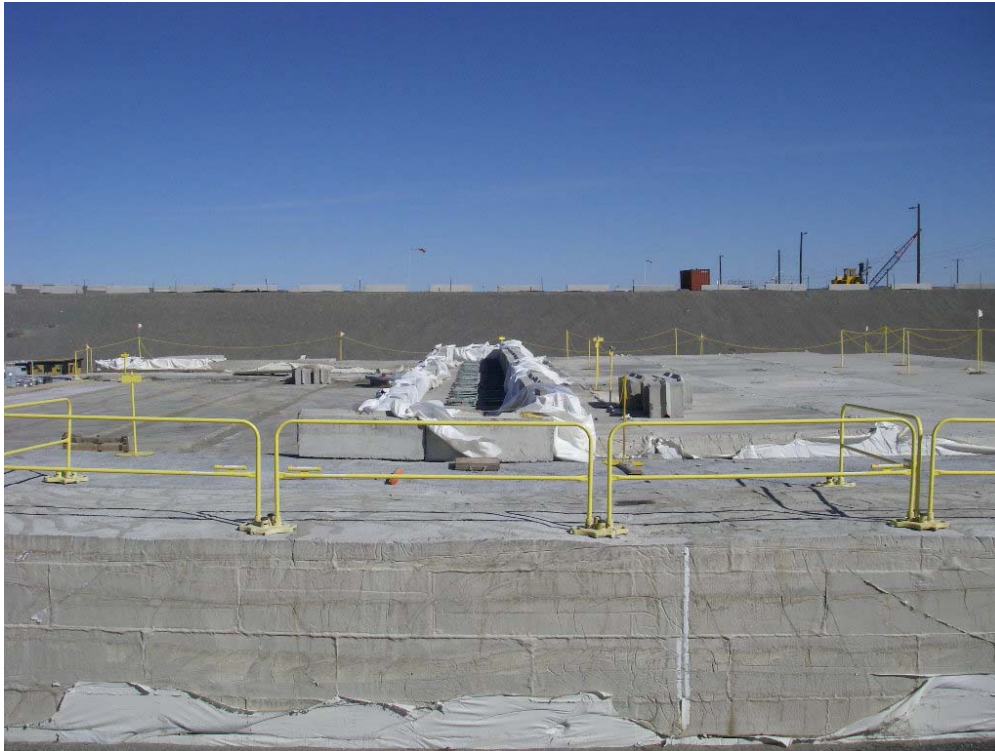
Photo#: IMGP0087 Date/Time: 3/22/2011 10:40:26 AM Photographer: A. Ruhs
Description: Partially finished Macroencapsulation treatment of HTGR (MLLW) inside of Trench 34. North facing.

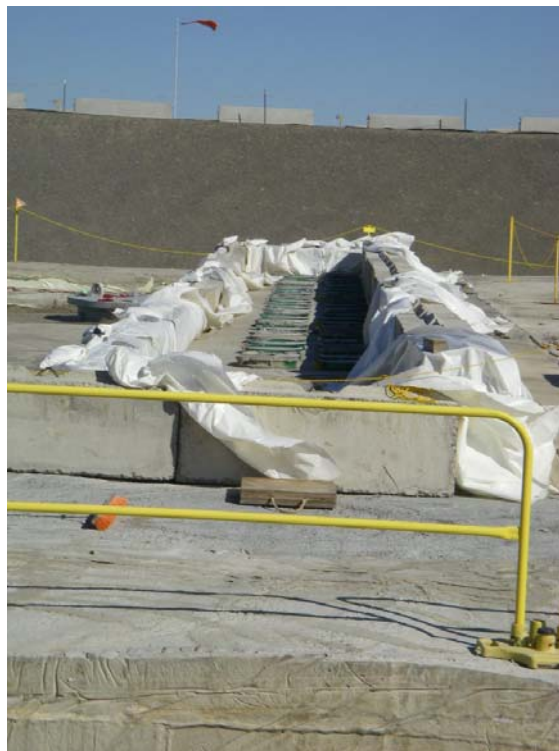
Photo#: IMGP0088 Date/Time: 3/22/2011 10:40:37 AM Photographer: A. Ruhs
Description: Close-up of partially finished Macroencapsulation treatment of HTGR (MLLW) inside of Trench 34. North facing.
